Operating Experience Weekly Summary 97-42

October 10 through October 16, 1997

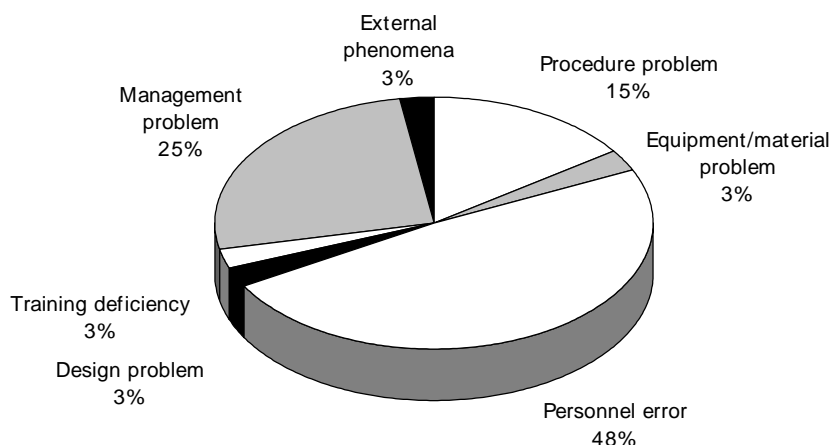
OEAF engineers searched the ORPS database for dropped drums and containers across the DOE complex and found 42 occurrences. Figure 1-1 shows that facility managers reported personnel error as the root cause for 48 percent of the occurrences. They also reported that management problems accounted for 25 percent of the occurrences. Further review shows that 58 percent of the personnel errors were reported as inattention to detail, and 30 percent of the management problems were reported as policy not adequately defined, disseminated, or enforced.

Figure 1-1. Distribution of Root Causes for Dropped Drums and Containers¹

These events underscore the importance of waste handlers ensuring that drums and containers are properly secured when transporting them. A dropped container could be breached, resulting in a spill of hazardous materials. Spilled materials can cause environmental damage, contamination of equipment, and contamination or injury to personnel. Clean-up of preventable spills not only results in additional costs, but usually generates more waste material. Truck drivers have full responsibility for the safe operation of the vehicle and for securing the load. They should be careful to avoid sudden changes in direction or emergency stops. Acceleration, deceleration, and turns can put high dynamic forces on the load and securing devices. Forklift operators should carry loads slightly tilted back and as low to the ground as reasonable. If the load blocks forward vision, operators should drive in reverse, unless a flagman is available. It may also be necessary to back down inclines when carrying a load. Restraining devices and tie-downs should be checked to ensure they are in good working order, and drivers should choose routes that take advantage of better roads. Securing drums or containers during handling may not always be practical, such as during loading or unloading. Waste handlers should exercise extra care when

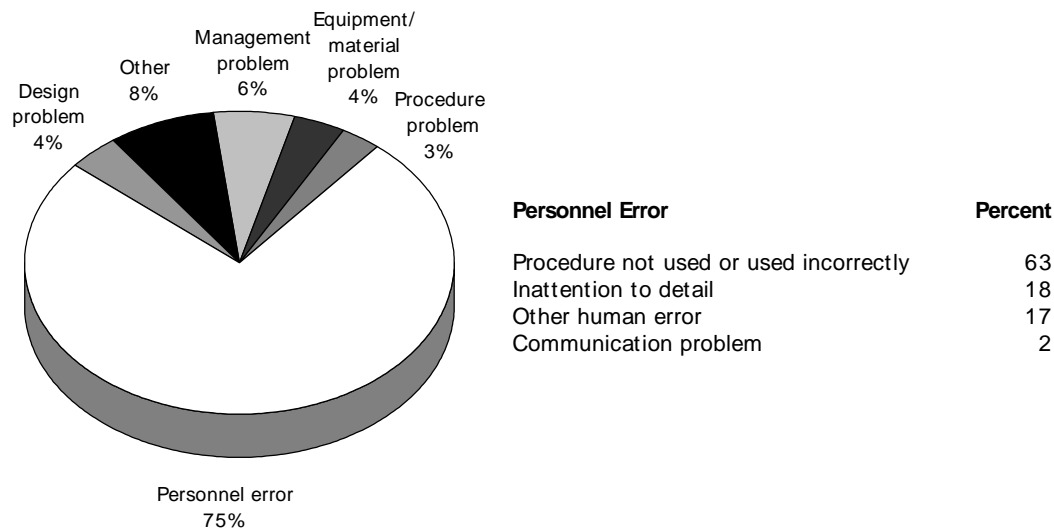
OEAF engineers searched the ORPS database for reports involving fall protection and found 135 occurrences. Figure 2-1 shows the distribution of direct causes reported by facility managers for these events. Personnel error represented 75 percent of the direct causes. Procedure not used or used incorrectly accounted for 63 percent of the personnel errors.

Figure 2-1. Distribution of Direct Causes for Fall Protection Events¹

This event illustrates the need for managers to closely supervise subcontractors that perform construction work at DOE facilities. Managers should provide safety oversight of subcontractor administrative controls, safety programs, and work plans to ensure subcontractor personnel perform work safely and in safe working environments. Managers should review the following Order, standard, and OSHA regulations to ensure all aspects of safety are addressed in procedures and that available operating experience information is incorporated into safety programs. In 1994, the Bureau of Labor Statistics reported 32 construction fatalities because of falls. Falls represented 10 percent of all fatalities in 1994.

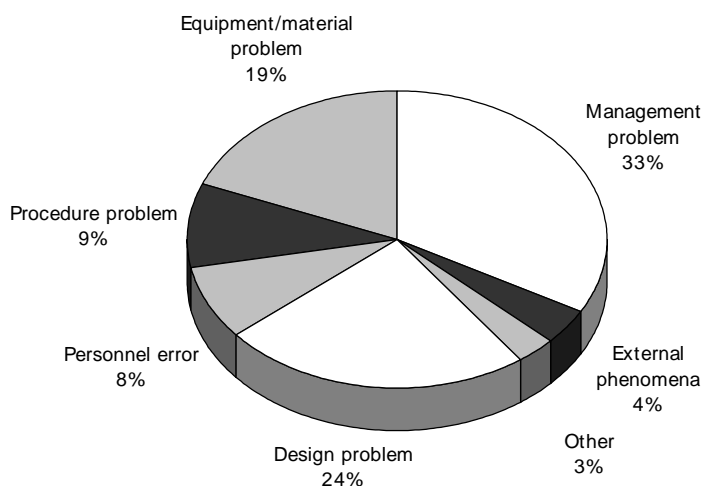
OEAF engineers searched the entire ORPS database and found 453 freeze protection events. Figure 3-1 shows the root causes for these events. A review of these events shows that 33 percent of these events were attributed to management problems, with an additional 24 percent attributed to design problems. Further analysis revealed that 32 percent of management problems were attributed to work organization/planning deficiencies; an additional 31 percent were attributed to inadequate administrative control. This indicates that if facility managers convey the importance of thorough freeze protection plans to employees responsible for developing them, many events could be avoided. Figure 3-2 shows the distribution by nature of occurrence for these events. A review by nature of occurrence shows that 59 percent of freeze protection events affected the facility condition. Further analysis revealed that 44 percent of events affecting facility condition were attributed to vital system/component degradation; an additional 34 percent affected operations. Site reviewers should use lessons learned from these occurrences when conducting assessments of current freeze protection programs, equipment, and systems.

Figure 3-1. Distribution of Root Causes for Freeze Protection Events¹

Facility managers should review their systems and equipment maintenance histories, policies, procedures, and work-planning processes and should walk-down systems to identify potential cold weather problems. Facility managers should also identify corrective actions and implement them before problems occur.

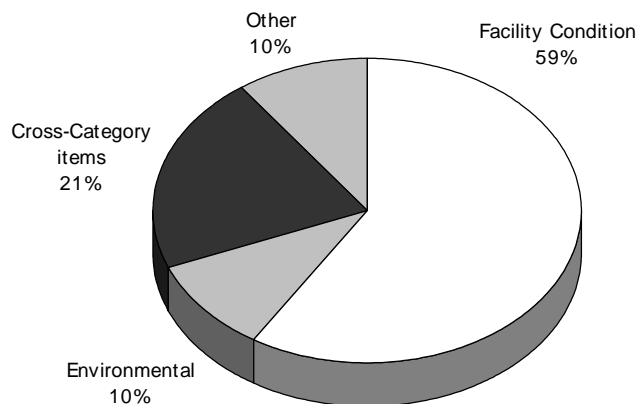
Figure 3-2. Distribution of Nature of Occurrences for Freeze Protection Events¹
